# Rehabilitation and completion works at Bumbuna Falls HEP: a case history of interrupted and continued implementation activities

**Bela Petry**  
Consultant  
Kolk 1  
2611 KC Delft, Netherlands

**Alberto Bezzi**  
Studio ing.G.Pietrangeli  
via cicerone 28  
00193 Roma, Italy

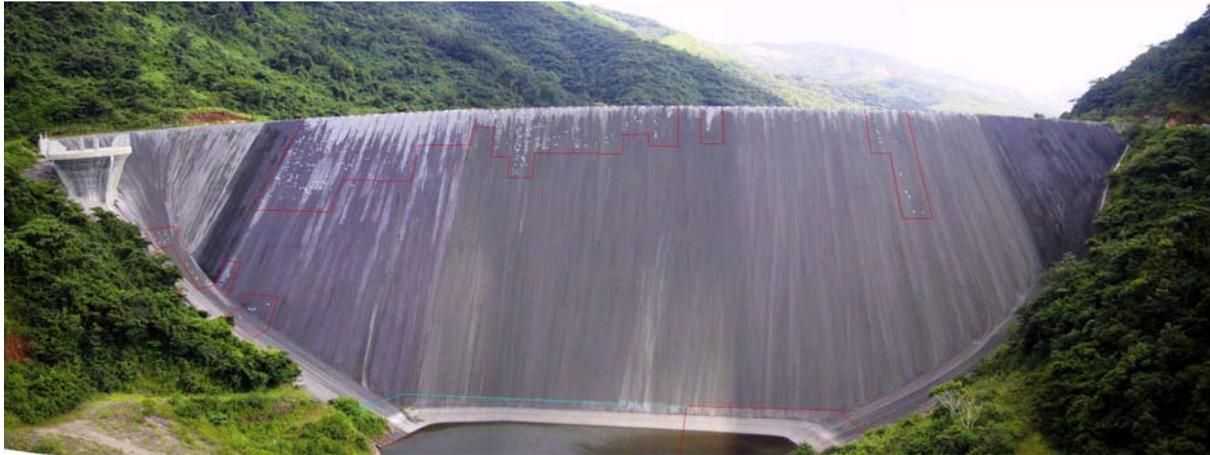
Visual inspection showed the occurrence of fissures, cracks and ripples in extensive areas of the upstream face corresponding to about 35 % of the total surface.

- Cracks – Large and deep cracks crossing the entire impervious layer, or penetrate deeper than half of the layer thickness were detected over an area of about 1000 m<sup>2</sup>. Repair works were considered necessary to restore the functionality of the lining in these areas
- Fissures - Fissures penetrating less than 2 cm into the layer were detected over an area of about 15000 m<sup>2</sup>. Repair works were also deemed necessary to assure the long term performance of the lining in these areas
- Superficial Fissures – Patterns of surface fissures were present over almost the entire dam facing. In these areas the treatment could be restricted to the application of the sealing coat.

*Figure 3-Impervious facing at the end of the interruption period*

On the basis of results of the site inspections and the laboratory tests, the following causes for the impervious membrane quality decay were identified:

- ageing phenomena of surface-level bitumen (oxidation, hardening, loss of adhesion) due to long term exposure to air and sunshine without a sealing coat protection,
- high temperatures reached by the lining due to direct exposure to sun radiation without the mitigation effect of an impoundment.

It is also likely that, in the areas where major fissures were observed, the quality of the impervious layer was inferior to that of other parts of the lining due to different placing and compaction conditions or other reasons related to the mix characteristics (performance of anti-stripping agent, filler-bitumen ratio, etc) causing the acceleration of the ageing phenomena and the occurrence of deeper fissures.

The impervious facing was completely rehabilitated by a sequence of operations that included:

- Milling the face surface to a depth of 3 cm, except in the zones where the upper layer had not been completed before interruption. The minimum thickness of 3 cm was considered a suitable average value based on samples cored in the areas where the effects of the ageing phenomena were more noticeable.

- Placing of a 6 cm thick impervious layer over the entire face area and protection by a seal coating to prevent against ageing effects

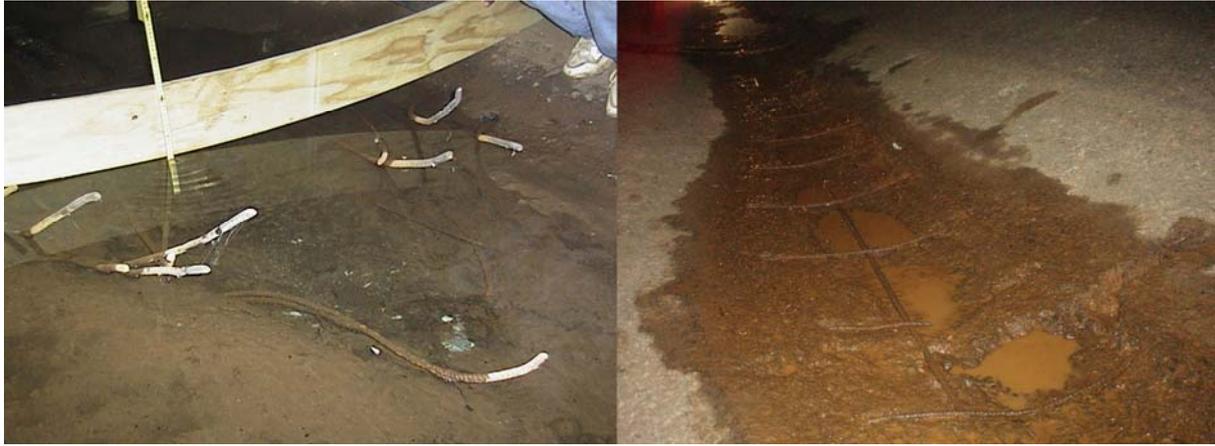
The extended use of the right and left tunnels for diversion purpose (1992 – 2004) has resulted in similar erosion phenomena in the concrete lining of both tunnels. The main types of erosion occurrences observed during site inspections can be classified as follows:

- Deep erosion - The occurrence of intense erosion effects in the invert zone was observed in both tunnels. Affected areas, extending over the entire tunnel length and a 2 to 4 m wide strip in the invert zone, are indicative of erosion mainly caused by sediments transported by the flow during the diversion period. The maximum erosion depths observed in different sections ranged from 2 to 12 cm. In some locations, steel meshes and reinforcement bars were exposed and damaged. The occurrence of deep holes with depth ranging from 10 to 25 cm was observed near the steel lined sections and in locations where steel reinforcements were destroyed.

*Figure 4-Erosion along tunnels invert zones*

**Deep erosion** (surfaces with irregularities greater than 4 cm) – deep erosion occurred mainly in the invert zones. The following technical guidelines were adopted for the treatment of such occurrences:

- Minimum 5 cm deep cut- out and removal of the concrete by scarification down to 2 cm below the pre-existing reinforcements.
- Cleaning of base surfaces requiring an overlay by high pressure water jets to enhance bonding
- Brushing of reinforcements to eliminate adhered concrete, rust and oxidations.
- Where the existing reinforcements were eradicated, the bars have been replaced
- Use of a mix consisting of sand, cement and synthetic resin emulsion as bonding agent

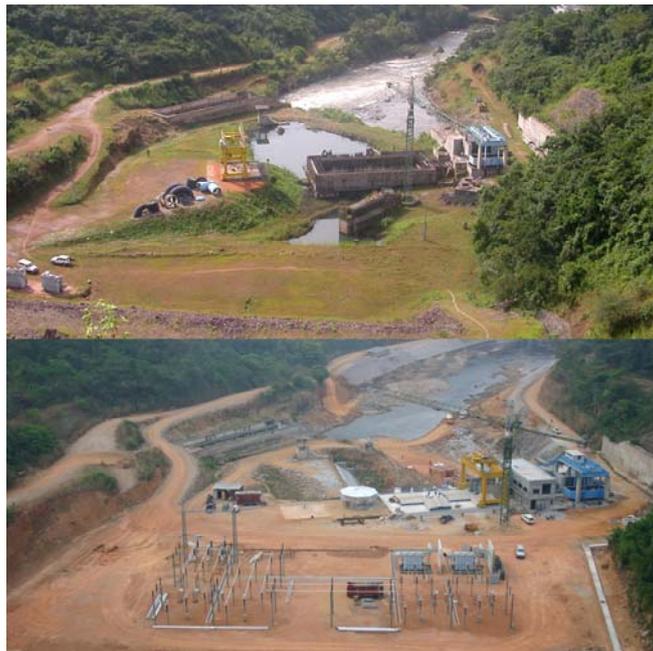
Figure 5-Rehabilitation and completion works in the Powerhouse and Substation area

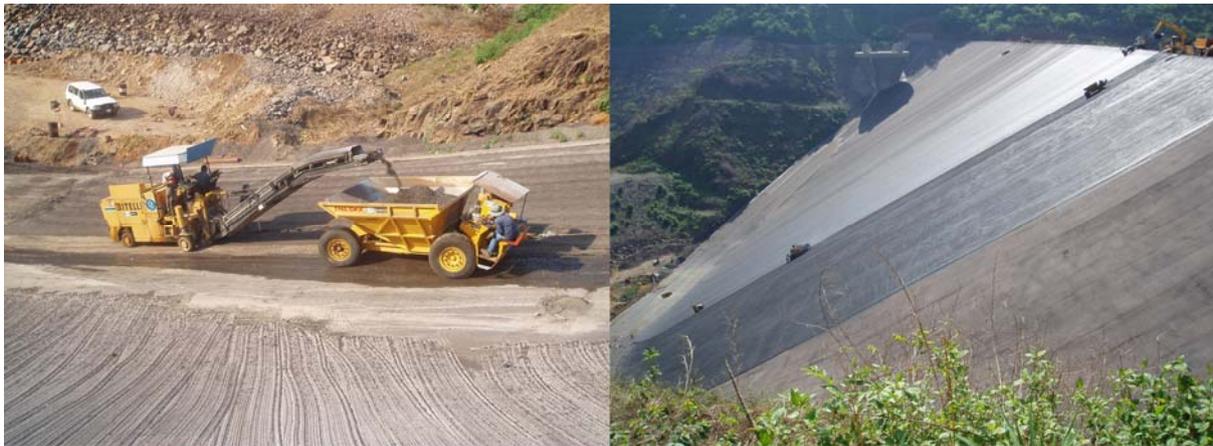
*Figure 6–Rehabilitation works of the asphalt concrete facing*

- Rehabilitation works along the cut-off wall by replacing damaged copper foils and removal of vegetation (e.g. roots).
- Cleaning of the entire milled surface from debris, oil patches; drying and application of an emulsion (tack coat) by spraying, in order to ensure an effective bond between the old and the new impervious layer.

- Execution of a 300 m<sup>2</sup> area trial facing and testing
- Placement of the impervious lining in the areas that had not been executed before the interruption of works.

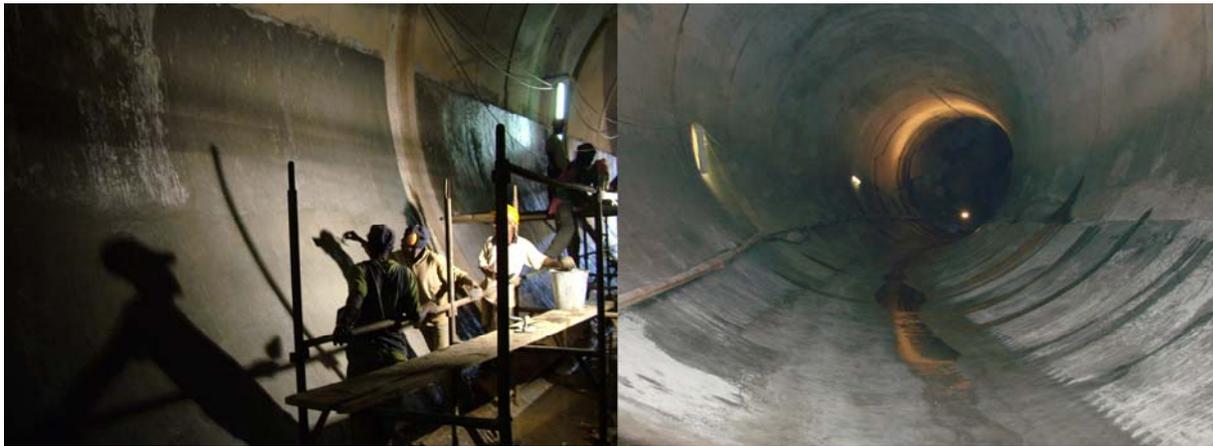
*Figure 7-Tunnel rehabilitation works*

- Cleaning of eroded surfaces using water jets at operating pressures of 200 bars, in order to remove eventual loose material and eliminate oil and grease as well as organic and inorganic deposits.
- Wetting the cleaned surfaces up to complete saturation, one day prior to mortar application; removal of excess water by compressed air jet a few hours before the application
- Use of a pre-packaged fibre reinforced and shrinkage free mortar, applied to the prepared surface by a flat trowel. The high strength (40 MPa) characteristics of the mortar, along with the proper preparation of the surface were considered necessary to secure the required bonding and resistance of repaired parts.

**Finishing-** all surfaces repaired using the procedure described above were finished using a pre-packaged two-components cement mortar; application using a flat trowel to a maximum thickness of 3-4 mm

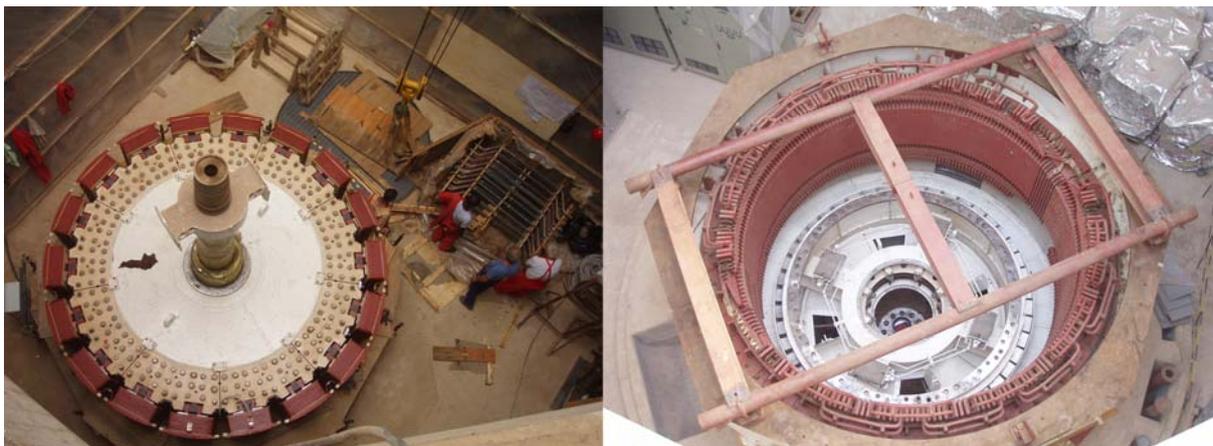
- Rotor poles- several rotor poles have been found badly rusted and displayed a very low insulation capacity; 8 poles were sent to the manufacturer’s workshop for rehabilitation while the remaining ones have been properly maintained at site using heating. The tests performed after the erection of the Unit 1 rotor were found to be satisfactory

*Figure 8-Assembly of generator rotor and stator after rehabilitation*

- Stator halves- moisture and contaminants were removed by cleaning and heating. Refurbishment of a number of coils was carried out by the generator Manufacturer.
