Slope stability monitoring: an Ethiopian case study - Gibe III power house

Alessandro Cagiano
Studio Ing. G. Pietrangeli Srl
Via Cicerone 28 - 00193
Rome
Italy

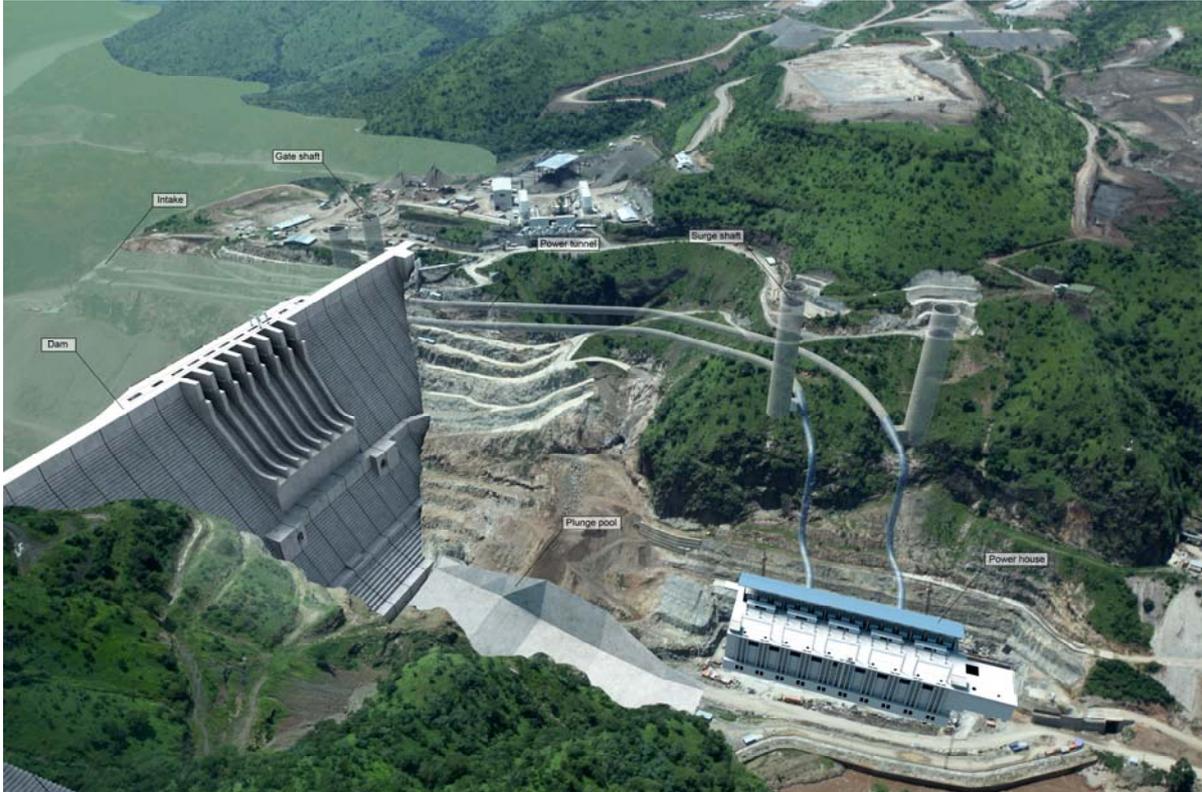
Fig. 1. General layout of the project (Rendering model)

Gibe III is the third plant of the Gibe–Omo cascade that comprises Gilgel Gibe (IP = 200 MW) and Gibe II (IP = 420 MW), both operating, together with Gibe IV and V which are planned. The general layout of the Gibe III project is shown in the rendering model of Fig. 1.

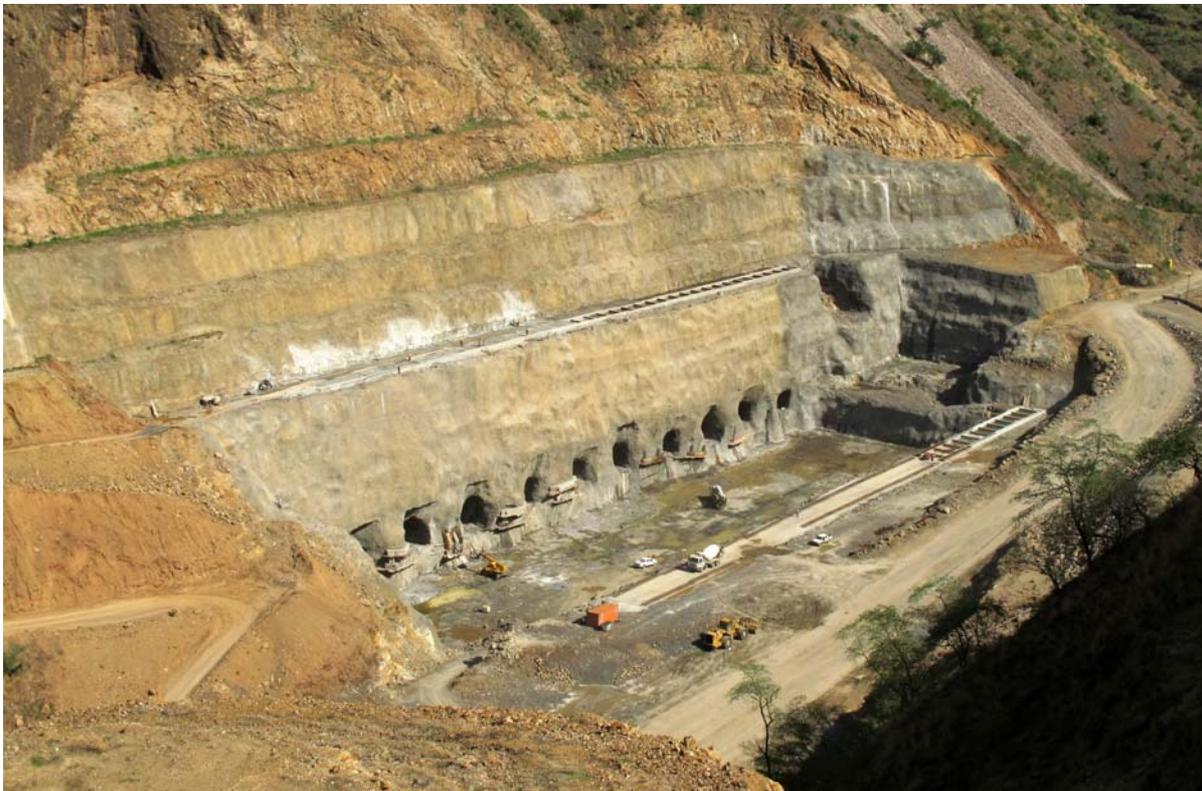
Fig. 2. Panoramic view of the Power House excavation front during concreting
