# DAM FOUNDATION GROUTING at GIBE III DAM: A CASE STUDY

This paper illustrates the main features of the grouting works, the injection parameters, the observed correlations between rock-mass characteristic, permeability, grout take and the closure criteria adopted for the curtain grouting.

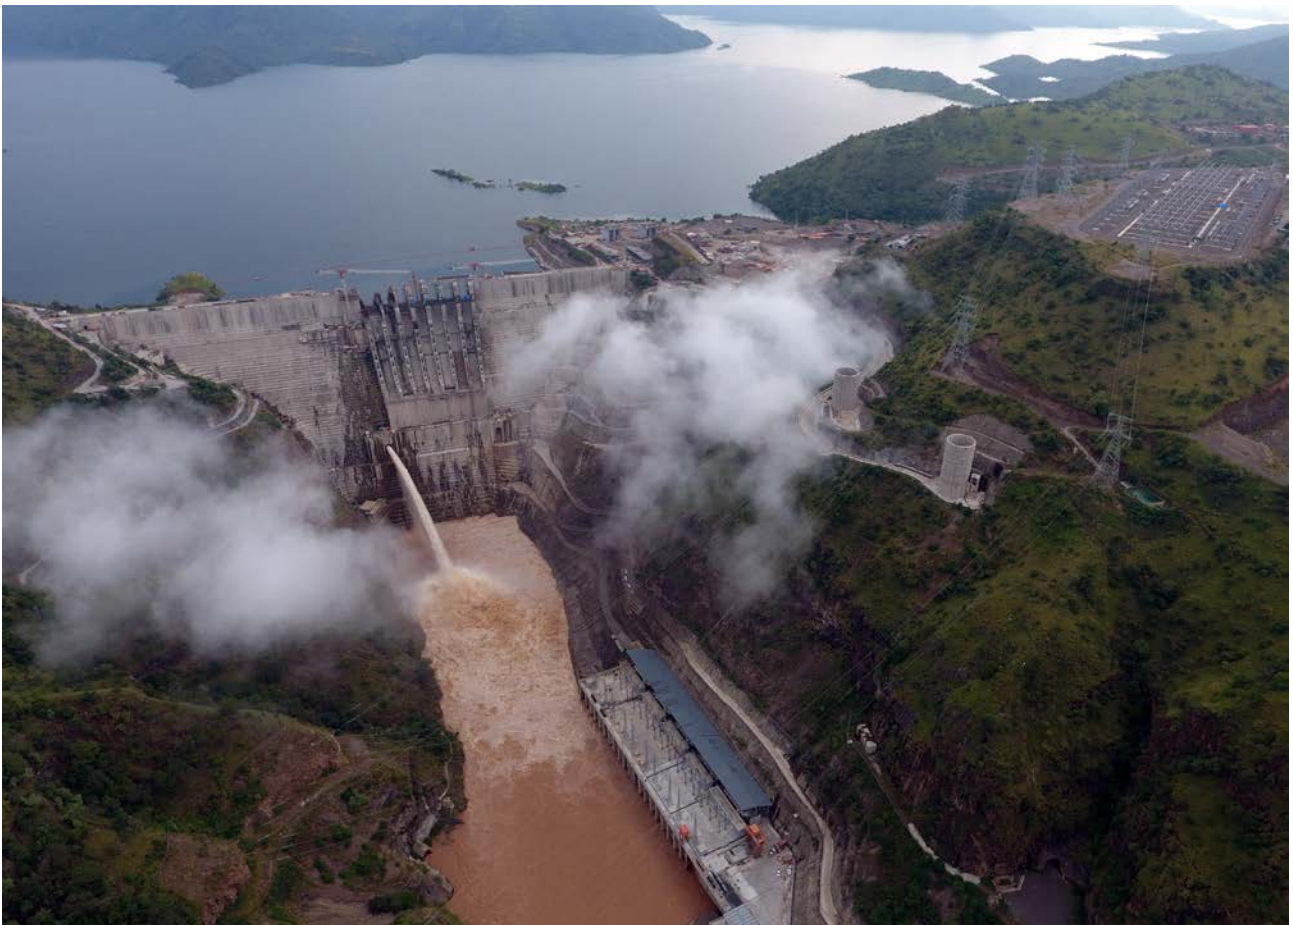
Fig. 1 – View of the dam: spillway under construction, right Middle Level Outlet discharging about 750 m<sup>3</sup>/s (October 2016)

The project is almost completed (spillway works and radial gates installation on the central portion of the dam crest are on-going). The impounding started at the beginning of 2015, bringing forward the power production which started in October 2015. At the end of the 2016 rainy season the reservoir level had reached elevation 865 m a.s.l., corresponding to a maximum head of about 215 m over the dam foundation.

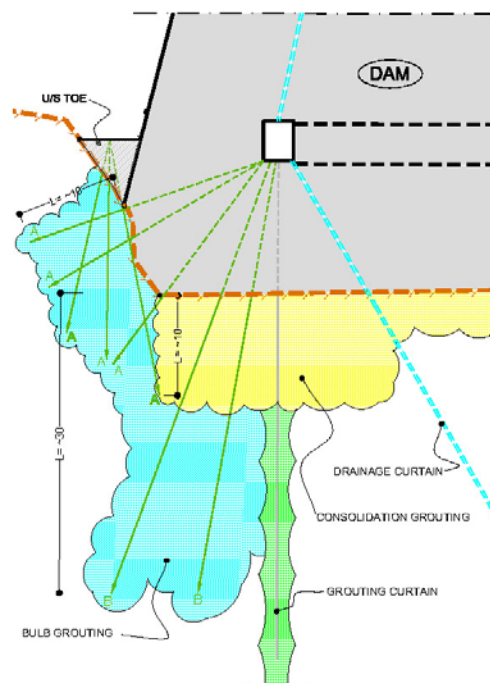
Fig. 3 – Main components of Gibe III dam grouting

The dam grouting basically includes three main components (Figure 3):

- contact/consolidation grouting;
- bulb grouting;
- curtain grouting.

Contact/consolidation grouting was carried out all along the foundation footprint from the RCC surface. It comprised of 10 m-deep holes, with a primary spacing of 3 x 3 m, in the upstream and downstream toe of the dam footprint and 3 m-deep holes, with a primary spacing of 6 x 3 m, in the central portion. Reduction of spacing and/or deepening of the holes was prescribed in correspondence with weak zones and/or depending on the take of the primary holes.

Bulb grouting completed the curtain grouting increasing the effectiveness of the screen near the dam upstream toe. It comprised of a primary pattern of 3 x 3 m holes with a length up to 30 m in the area close to the curtain grouting. Bulb grouting operations, as well as curtain grouting works, were executed mainly from the inspection galleries inside the dam body, one every 40 m of height and extended inside the dam abutments. A specific pattern of sewing holes was executed to connect the portions of the curtain executed from the galleries at different elevations.

Curtain grouting comprised of systematic primary, secondary and tertiary holes (spaced respectively 12, 6 and 3 m) with a 15° inclination in respect to the vertical for a better intersection with the main vertical joints of the rockmass. In the central portion of the dam these systematic holes were extended up to el. 600 m a.s.l. (i.e., about 50-60 m below the dam foundation level) to make sure that no local anomalies (such as altered zones or conductive joints) remained untreated in this substantially impervious area. Primary and secondary holes were systematically extended up to el. 550 m a.s.l. (i.e., upper portion of the deeper aquifer) with the aim to investigate the geometry of the aquifer roof and the possible presence of deeper weak zones. In some cases, depending on the grout take of primary and secondary holes, tertiary or even quaternary holes series were extended below el. 600 m a.s.l.. On the river banks the screen profile follows the main geotechnical features of the rock mass, encountered during the investigation campaign and excavation works.

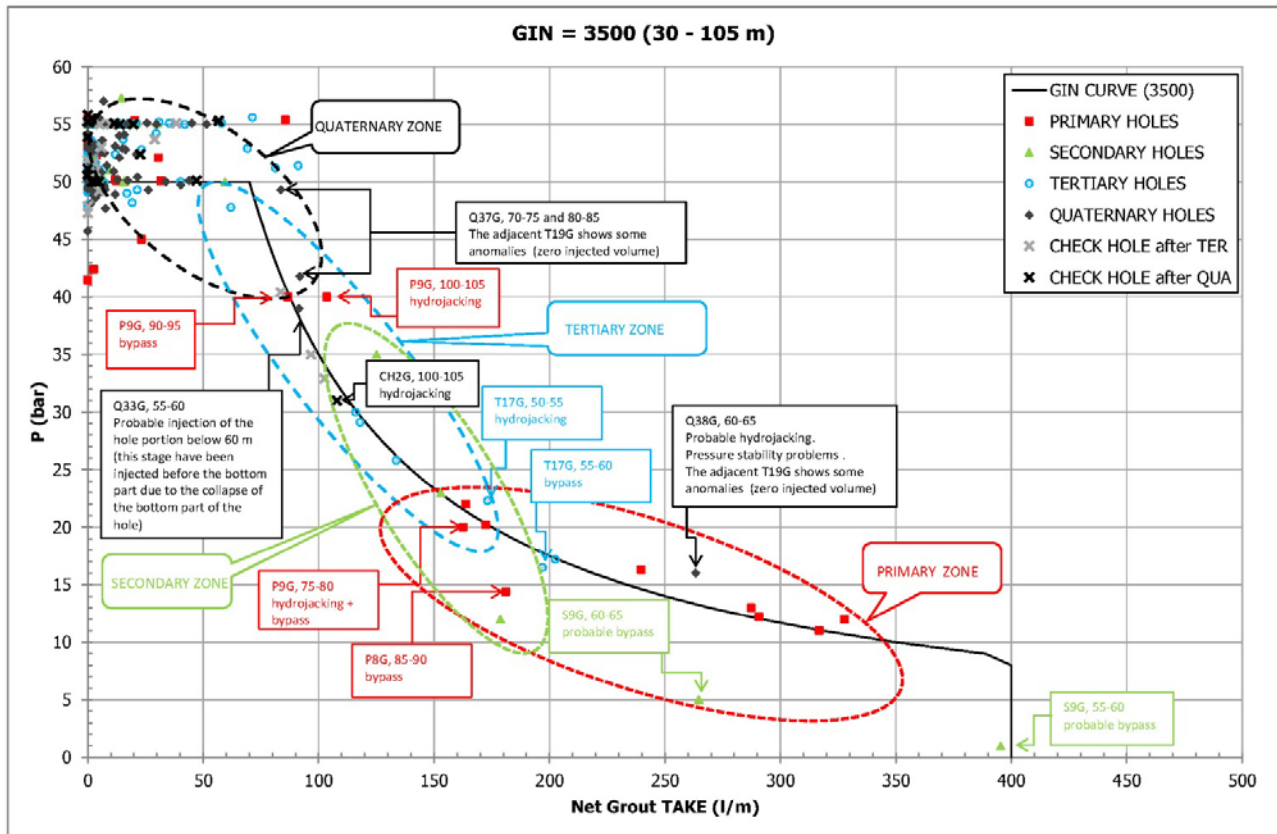
Fig. 5 – Typical trend of “final” pressure/volume points recorded in the central portion of the dam for the different hole series

The graph reported in the following figure illustrates the GIN limiting curve adopted for the portion of “zone C” rock mass located 30 m below the foundation level and the values of pressure/volume recorded at the end of the grouting path of each stage.

It may be observed that these points shift progressively towards the left side of the graph (higher pressures, lower takes) as the injections progress from hole series to hole series (the final injection zone of quaternary hole series clearly fall on the upper limiting pressure line). Some outliers may be observed in all the hole series (i.e., points which fall outside the final injection zones). Generally, these anomalous points are related to some anomaly recorded during the grouting (bypass, hydro-jacking, etc.).

The closure effect, which is fairly evident in this area, is of course less accentuated in the upper and less permeable portion of the foundation where the grout takes are generally lower and almost all the stages (for all the hole series) ends on the upper limiting pressure line.

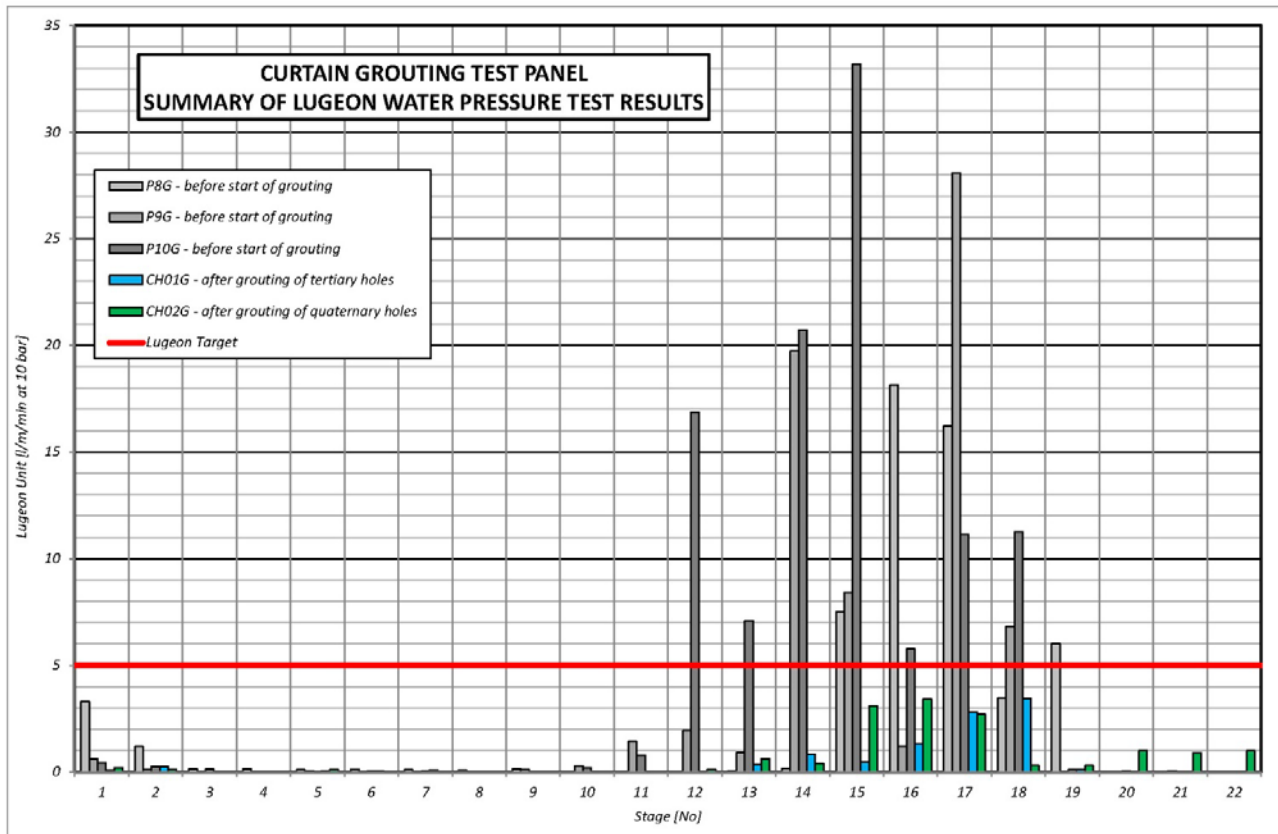
Fig. 6 – Lugeon Test values before and after grouting along test panel in the central portion of the dam

The reduction of permeability before and after grouting is illustrated in the following graph (Figure 6).

Three primary holes were water tested before grouting with standard Lugeon methodology following the progress of drilling works (downward, with stage lengths of 5 m) with five steps of ascending and descending pressure, 10 minutes of duration each and maximum pressure equal to 25 bar. The distribution of Lugeon values indicates a clear correspondence with the geological characteristics (RQD), and in particular:

- in the upper zone (from el. 650 to 600-590 m a.s.l.) the rock mass has a very low permeability, less than 1 UL (with the exception of the zone 5-10 m below the RCC-ROCK contact where the permeability slightly increases up to 2-3 UL, due to the disturbance and stress relief induced by the excavation);
- in the lower zone (from el. 600-590 to 570-560 m a.s.l.) the permeability is one order of magnitude higher than in the upper zone (15-30 UL);
- in the bottom part (from el. 570-560 to 550 m a.s.l.) the permeability is lower than 1 UL.

Water tests were carried out after completion of the tertiary hole series and quaternary hole series (holes CH1G and CH2G respectively).

It may be observed that, while in the upper and bottom zones the permeability of the rock mass expressed in terms of Lugeon Units remained substantially unchanged (the values are lower than 1 UL), in the “lower zone” (between elevation 600 to 560 m a.s.l.) the Lugeon values were reduced by one order of magnitude from 15-30 UL (before grouting) to a maximum of about 3 UL (after grouting), thus demonstrating the efficacy of the treatment in the fractured and permeable zone.

The red line in the graph represents the target value of foundation permeability (i.e., 5 UL) reported in the contractual documents.

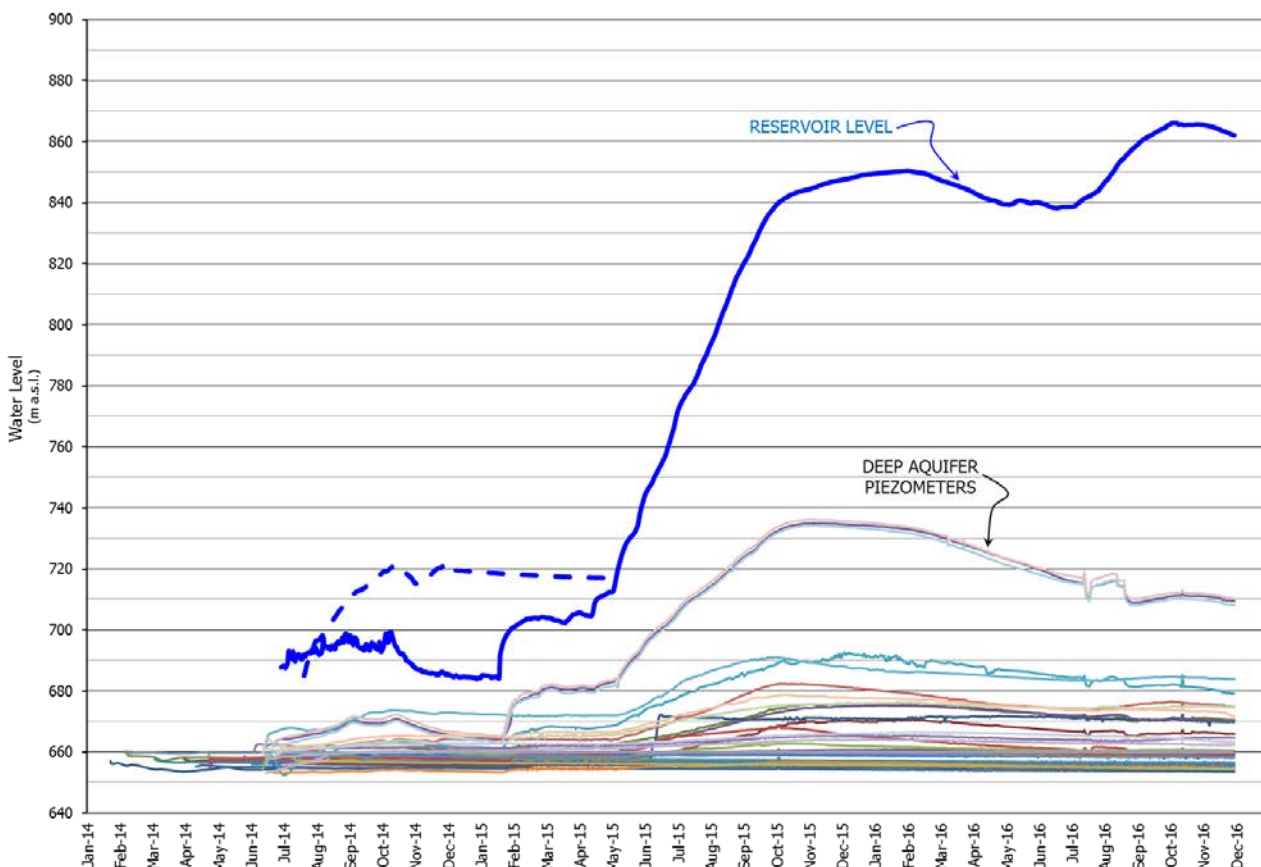
Fig. 7 – Piezometers in the lower dam gallery (660-665 masl): Uplift and Reservoir level vs Time

Monitoring of dam performance during impounding is currently on-going by means of the extensive instrumentation system installed. At the end of the 2016 rainy season the reservoir level had reached an elevation of about 865 m a.s.l., corresponding to a maximum head of about 215 m over the dam foundation. The overall behaviour of the dam and in particular of the foundation is fully satisfactory. The main findings can be summarized as follows (see Figure 7):

A linear correlation was observed between aquifer pressure and the reservoir water level with a coefficient of about 0.4 and substantially no lag-time (meaning that the recharge area shall be close to the dam). This correlation was almost constant from May 2015, when the reservoir overtopped the U/S cofferdam.

During and after the 2016 rainy season, when the reservoir started to rise again, a decrease in the deep aquifer pressure was observed.

This behaviour is substantially constant in the entire deep aquifer: no significant pressure differences have been observed among the piezometers in the upstream or downstream zone and even outside of the dam footprint.
